**A comparison of rates of decay and loss in stiffness of radiata pine and
Douglas fir framing lumber**

Mick Hedley, Dave Page and Jackie van der Waals
Scion Wood Processing, Private Bag 3020, Rotorua, New Zealand

Prepared for the 39th Annual Meeting

Istanbul, Turkey
24-29 May 2008

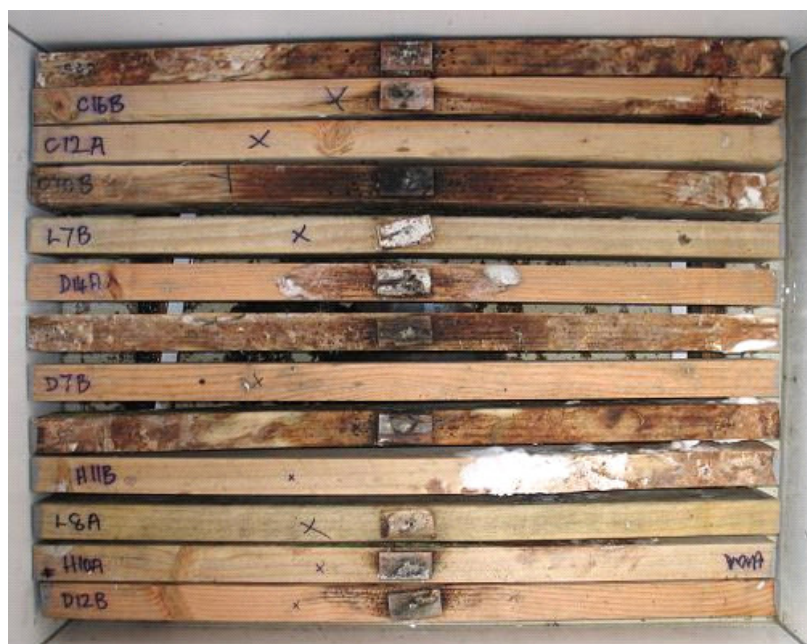
Fig 1. Arrangement of samples in the exposure tank

Prior to installation samples were immersed in water for two hours. They were then randomly placed on edge, with the feeder blocks facing upward, in 1.0 m (long) x 0.8m (wide) x 0.6 m (deep) plastic tanks (Fig 1). Layers of samples were separated by 10 x 10 mm plastic stickers. There was water in the tanks about 20mm deep. The tanks were placed on a level site at the Scion campus, in an area partly shaded by large trees.

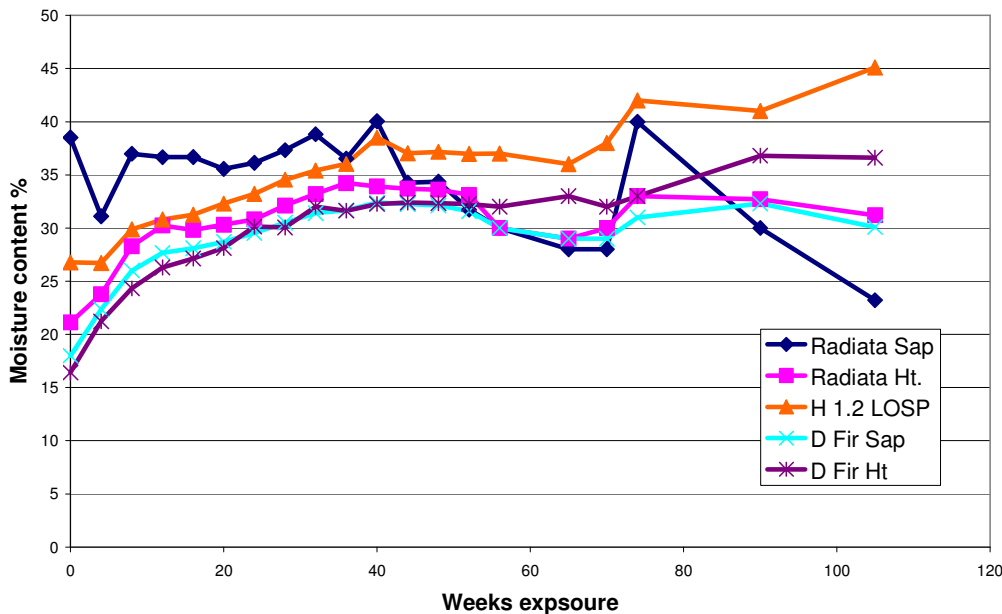
Fig 2 Mean moisture content of test samples

Moisture content calculations were based on sample weight (Fig 2.). Weight is reduced by significant decay and this will have made moisture content calculations inaccurate, particularly in the untreated radiata pine and latterly in the Douglas fir sapwood groups. They were taken mainly to ensure that moisture contents were suitable for decay throughout the duration of the test.

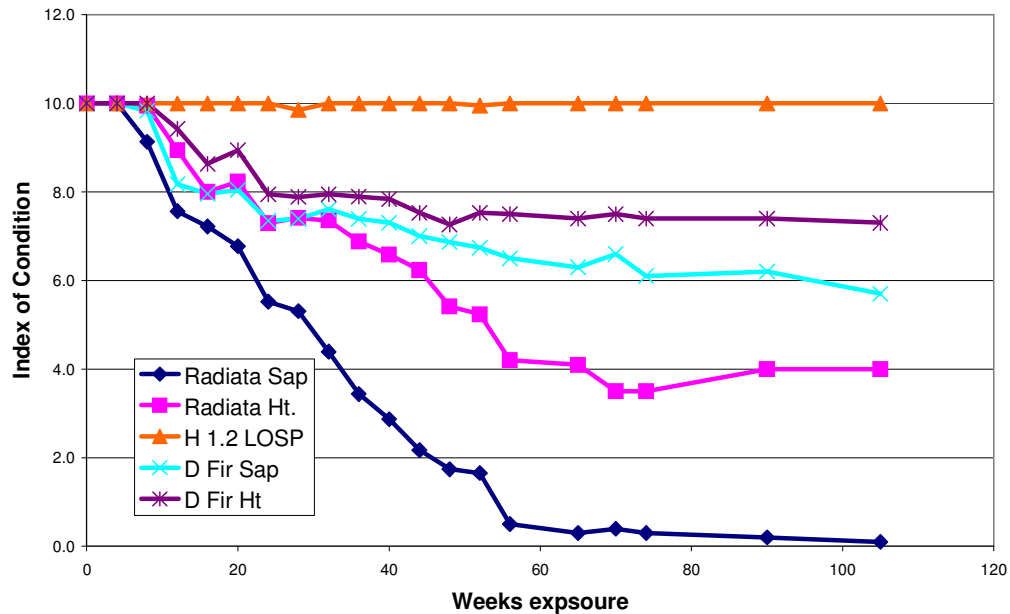
Fig 3 Index of Condition

Decay (Index of Condition) (Fig 3)

The first sample failed in the untreated radiata pine sapwood group after 20 weeks and the two that remained after 105 weeks were in poor condition. The first radiata pine heartwood sample failed after 48 weeks and 12 had failed at 105 weeks and there have been two failures in the Douglas fir heartwood group. There have been no failures in the treated radiata pine group

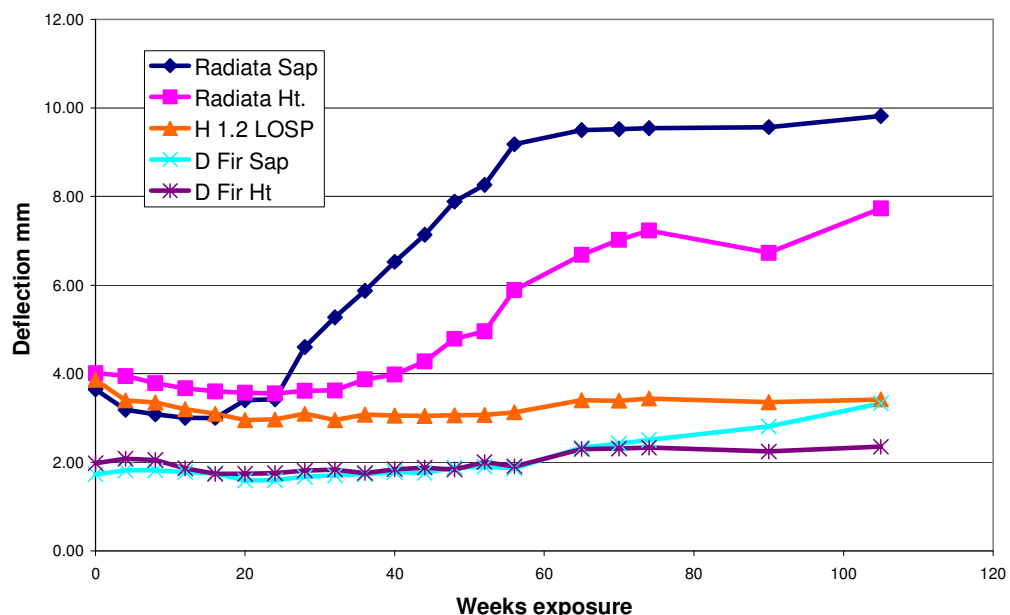
Fig 4. Deflection against time

From Fig 4 it is seen that the initial deflections for both Douglas fir sapwood and heartwood were approximately half that of the pine samples. The test rig was set up in such a manner that a deflection of 10mm occurred when the sample broke.

Untreated radiata pine sapwood decayed rapidly, although it wasn't until the mean Index of Condition fell below 6 that deflection under load exceeded that at the start. Untreated radiata pine heartwood had greater decay resistance and increases in mean deflection occurred more gradually.

Even though obvious decay was occurring in Douglas fir, where Indices of Condition were between 6 and 8 after 64 weeks, no loss in stiffness was recorded in that time. Significant loss in stiffness in Douglas fir sapwood only commenced at week 90 when Index of Condition was ~6. Neither Douglas fir heartwood nor H1.2 treated radiata pine showed any loss of stiffness during the 106 weeks exposure period.
